# Cornerstone Home Inspection

33 Arnold Street  
Providence, RI 02906

Prepared for: Bruce Long

06:45 December 16, 2009

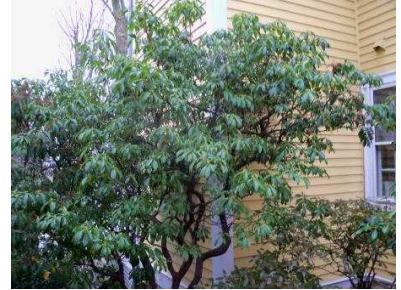
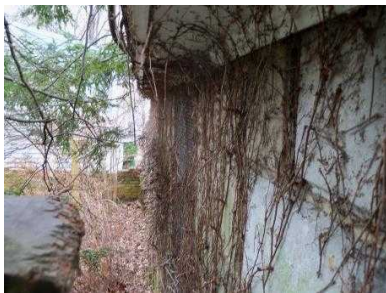
| 7. | <input type="checkbox"/> | <input type="checkbox"/> | <input type="checkbox"/> | <input type="checkbox"/> | <input checked="" type="checkbox"/> | Vegetation: Trees/shrubs <span style="color: red;">Tree limbs are in contact with house and garage and need to be cut back. Trim vegetation back 1' from house and garage in order to prevent moisture damage to siding.</span> |

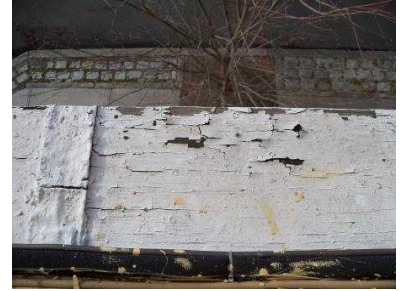
1.      Type: Cedar clapboard  
 2.      Trim: Wood **Peeling paint noted at west gable trim.**

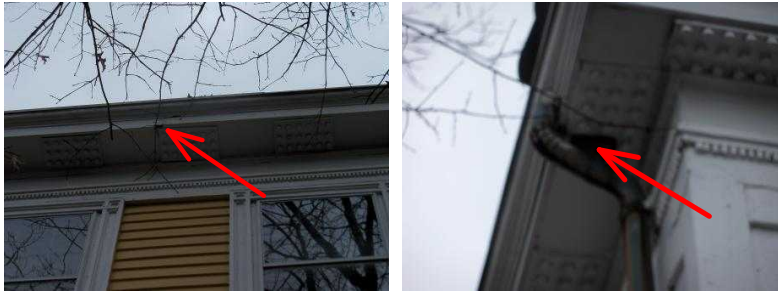
3.      Fascia: Wood  
 4.      Soffits: Wood **Deterioration noted at front soffit.**

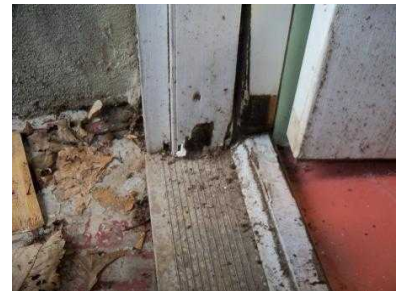
5.      Door Bell: Hard wired  
 6.      Entry Doors: Metal, Wood **Deteriorated jamb noted at basement door.**

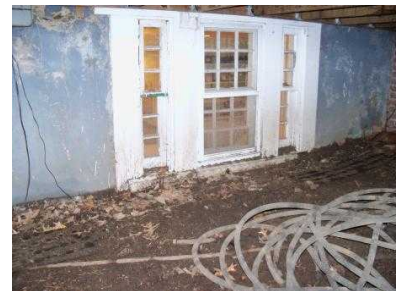
7.      Windows: Double hung  
 8.      Basement Windows: Foundation style, Double hung  
**Deteriorated sill noted at left rear double hung basement window.**

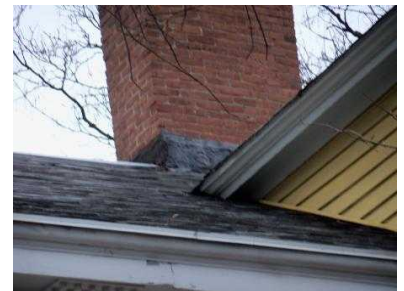
18.      Chimney: Brick
19.      Flue/Flue Cap: Unable to view due to height
20.      Chimney Flashing: Aluminum, Lead Temporary tar repair noted. A qualified roofing contractor is recommended to evaluate and estimate repairs.

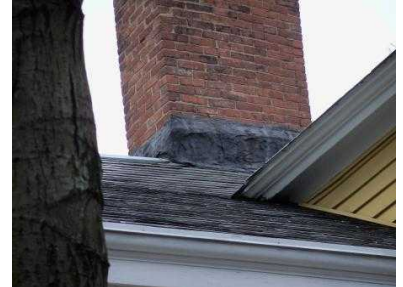
- 21.      Chimney: Brick
- 22.      Flue/Flue Cap: Unable to view due to height
- 23.      Chimney Flashing: Aluminum, Lead Temporary tar repair noted. A qualified roofing contractor is recommended to evaluate and estimate repairs.

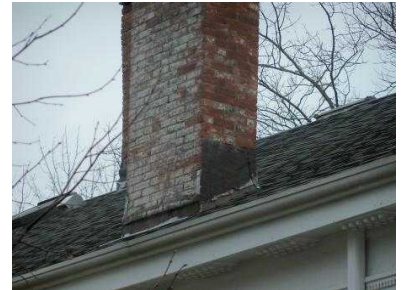
- 24.      Chimney: Brick
- 25.      Flue/Flue Cap: Unable to view due to height
- 26.      Chimney Flashing: Aluminum, Lead Temporary tar repair noted. A qualified roofing contractor is recommended to evaluate and estimate repairs.

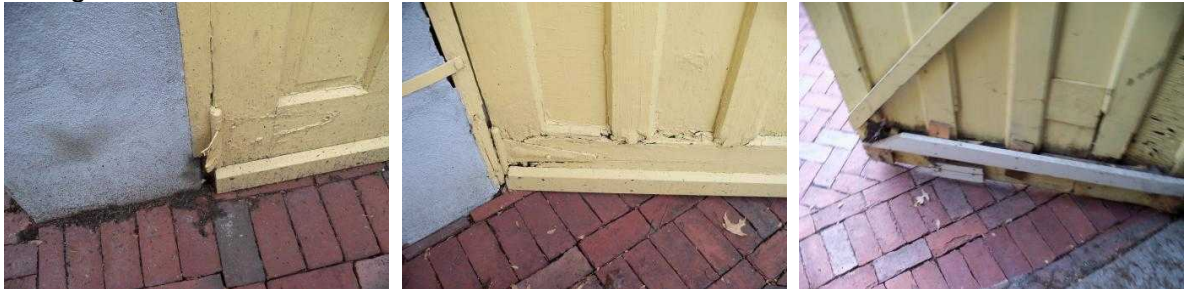
- 1. Type of Structure: Detached Car Spaces: 3
- 2.      Garage Doors: Wood Deterioration noted. Doors require replacement.

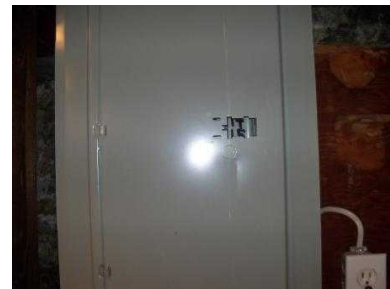
- 1. Service Size Amps: 200 Volts: 120-240 VAC
  - 2.      Service: Aluminum
  - 3.      120 VAC Branch Circuits: Copper
  - 4.      240 VAC Branch Circuits: Copper
  - 5.      Conductor Type: Romex
  - 6.      Ground: Plumbing and rod in ground
  - 7.      Smoke Detectors: Not Inspected
- Basement Electric Panel
- 8.      Manufacturer: Murray **Missing latch noted**

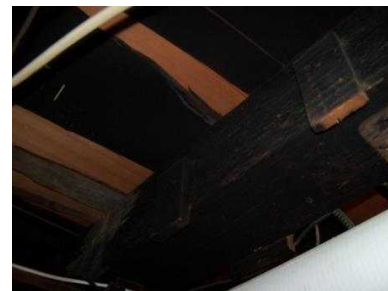
1.      Structure Type: Wood frame Charring noted in boiler room.

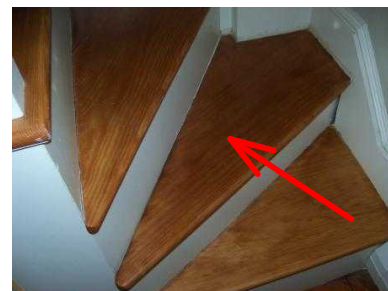
2.      Foundation: Brick, Stone
3.      Differential Movement: No movement or displacement noted
4.      Beams: Steel I-Beam, Solid wood
5.      Bearing Walls: Stone
6.      Joists/Trusses: 2x6, 3x8
7.      Piers/Posts: Steel posts
8.      Floor/Slab: Concrete
9.      Stairs/Handrails: Wood stairs with wood handrails  
Inadequate support noted at tread at wood stairs between 2nd and 3rd floor.

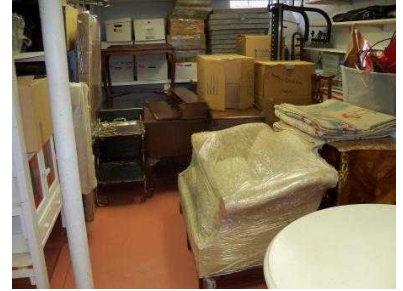
1.      **Unable to Inspect:** 30% Storage items and shelving. The basement was not completely inspected. Be advised that because we could not completely inspect the basement, hidden problems may exist that are not documented in this report. It is recommended that after obstructions are removed a full examination of the space be made prior to closing.

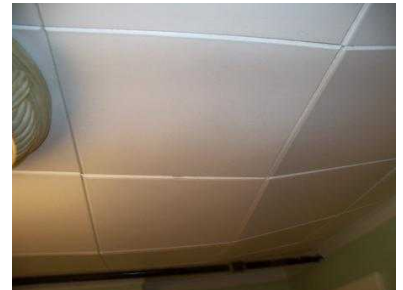
2.      **Ceiling:** Sheetrock, Fixed tile, Exposed framing Loose tile noted

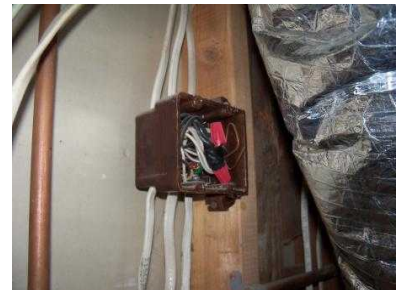
3.      **Walls:** Plywood, Stone, Pine  
 4.      **Floor:** Concrete  
 5.      **Doors:** Wood  
 6.      **Windows:** Foundation style  
 7.      **Electrical:** 110 VAC Cover needed at open junction box in boiler room.

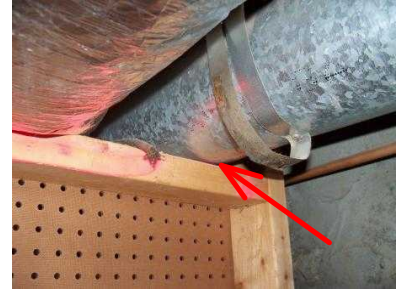
11.  Flue Pipe: Single wall **Inadequate clearance noted between vent pipe and combustibles.**

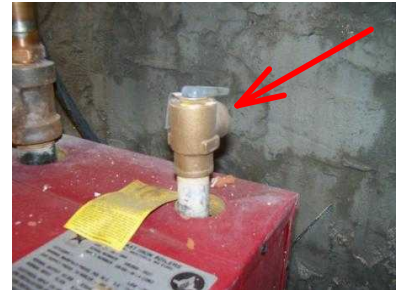
14.  Heating System Operation: Adequate  
15. Manufacturer: Smith  
16. Type: Boiler Capacity: 75,000 BTUHR  
17. Area Served: 3rd floor and basement Approximate Age: 9  
18. Fuel Type: Natural gas  
19.  Heat Exchanger: 3 Burner  
20. Unable to Inspect: 10%  
21.  Distribution: Baseboard  
22.  Circulator: Pump  
23.  Draft Control: Automatic  
24.  Flue Pipe: Single wall  
25.  Controls: Relief valve **Missing discharge line noted**

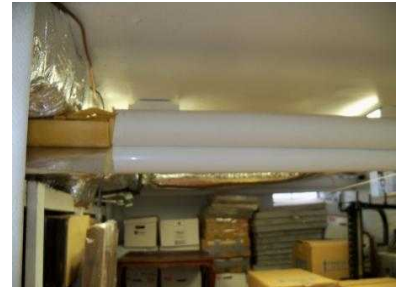
26.  Devices: Zone valves  
27.  Thermostats: Multi-zone  
28. Suspected Asbestos: No Encapsulated asbestos noted in basement.

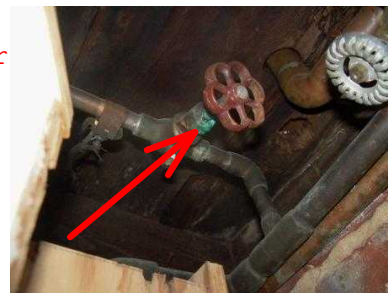
- 1.      Service Line: Copper
- 2.      Main Water Shutoff: Basement
- 3.      Water Lines: Copper Leaking gate valve noted behind basement bathroom access panel. A licensed plumber is recommended to evaluate and estimate repairs.

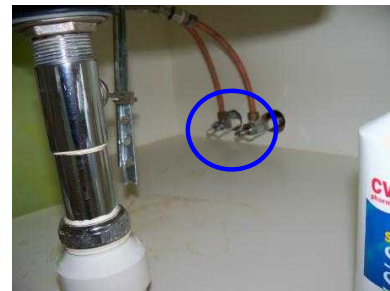
| 21. | <input type="checkbox"/> | <input type="checkbox"/> | <input type="checkbox"/> | <input checked="" type="checkbox"/> | <input type="checkbox"/> | <input type="checkbox"/> | Faucets/Traps: Missing handles noted at sink supply line shutoff valves. |

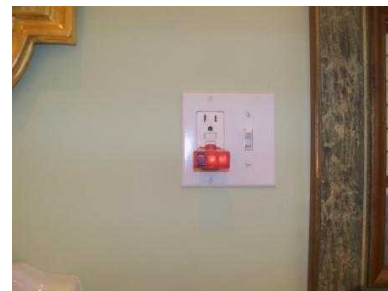
- 50.      Ceiling: Plaster
- 51.      Walls: Plaster
- 52.      Floor: Hardwood
- 53.      Doors: Wood
- 54.      Windows: Double hung
- 55.      Electrical: 110 VAC GFCI Outlet does not trip when tested and requires replacement.

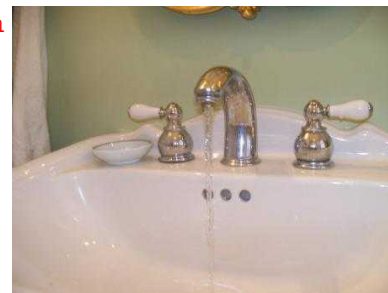
- 56.      Sink/Basin: Pedestal
- 57.      Faucets/Traps: Hot water at sink faucet does not turn off. A licensed plumber is required to evaluate and estimate repairs.

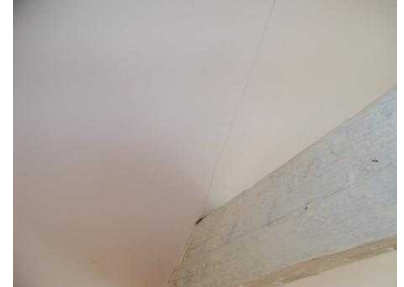
1.      Closet:  
2.      Ceiling: Plaster **Cracks present**

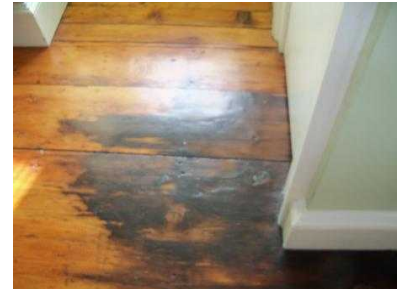
3.      Walls: Plaster  
4.      Floor: Pine **Loose flooring noted**

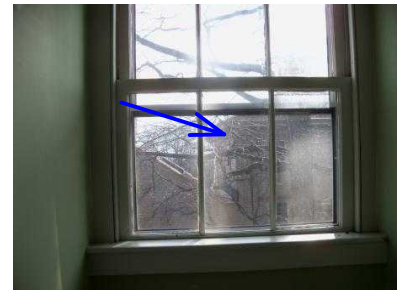
5.      Doors: Wood  
6.      Windows: Double hung **Cracked pane noted at front window**

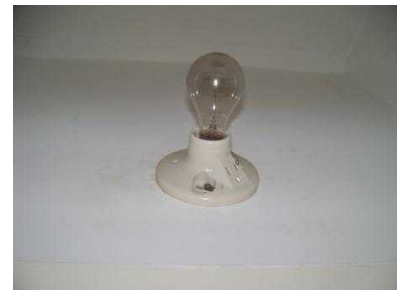
9.      Closet: Single  
10.      Ceiling: Plaster  
11.      Walls: Plaster  
12.      Floor: Pine  
13.      Doors: Wood  
14.      Windows: Double hung  
15.      Electrical: 110 VAC **Exposed light bulb noted in closet. This is a potential fire hazard if close or storage items come in contact with bulb.**

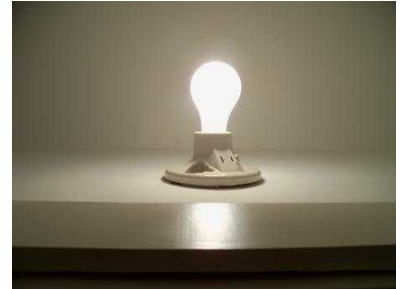
23.      Electrical: 110 VAC Exposed light bulbs noted in closets. This is a potential fire hazard if close or storage items come in contact with bulb.

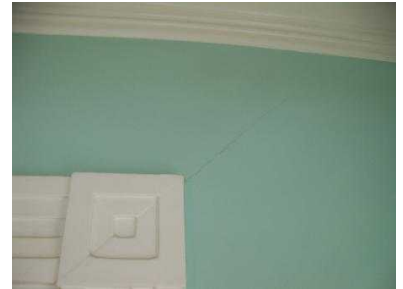
27.      Walls: Plaster Crack noted above entry door

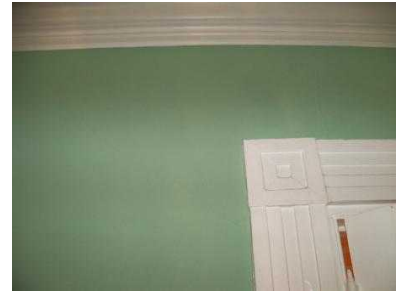
35.      Walls: Plaster Cracks noted above entry door.

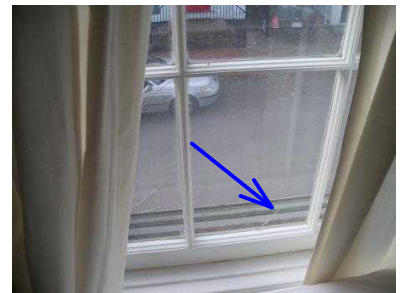
38.      Windows: Double hung Cracked pane noted at right side window

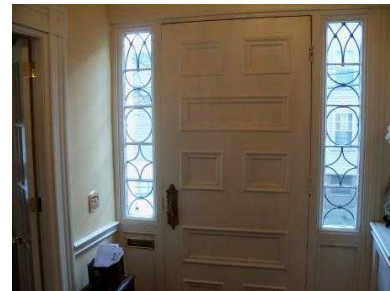
12.      Doors: Wood **Front door sticks at jamb**

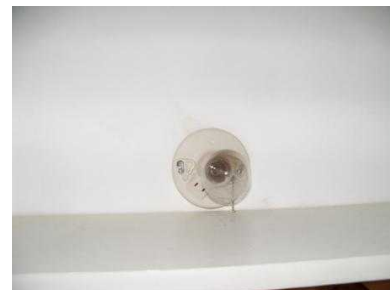
14.      Electrical: 110 VAC **Exposed light bulb noted in closet. This is a potential fire hazard if close or storage items come in contact with bulb.**

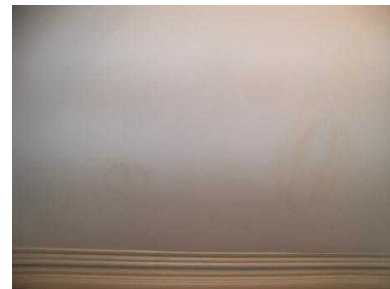
23.      Ceiling: Plaster **Inactive water stains noted**

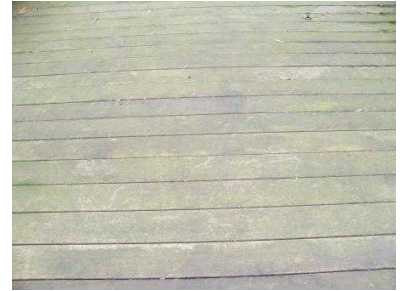
1. Deck: Treated wood [Clean and reseal](#)

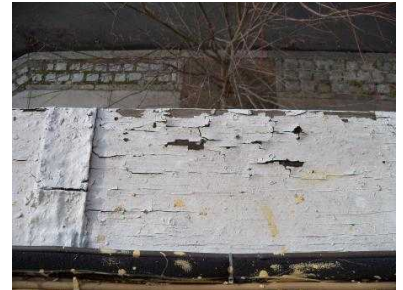
2. Trim: Wood [Peeling paint noted at west gable trim.](#)

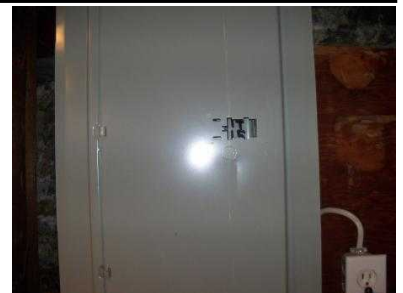
4. Basement Electric Panel Manufacturer: Murray [Missing latch noted](#)

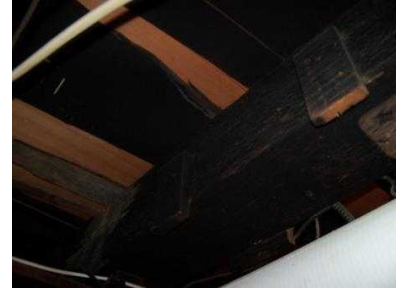
5. Structure Type: Wood frame [Charring noted in boiler room.](#)

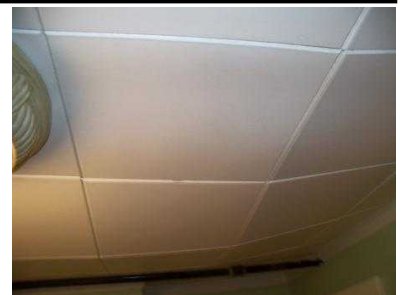
6. Ceiling: Sheetrock, Fixed tile, Exposed framing [Loose tile noted](#)

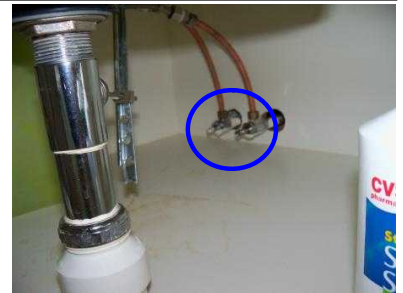
7. 2nd floor off of sitting room Bathroom Faucets/Traps: [Missing handles noted at sink supply line shutoff valves.](#)

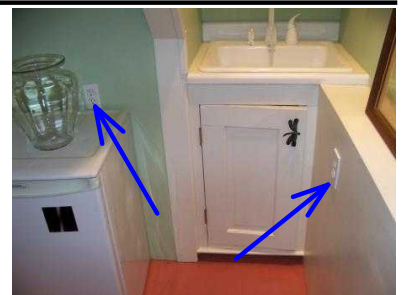
8. Basement Kitchen Electrical: 110 VAC [GFCI outlets needed next to sink.](#)

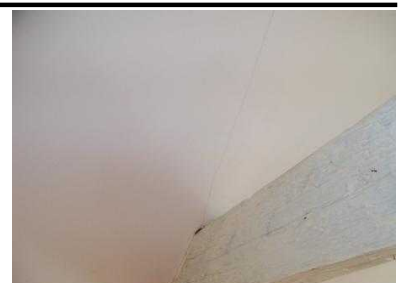
9. 3rd left Bedroom Ceiling: Plaster [Cracks present](#)

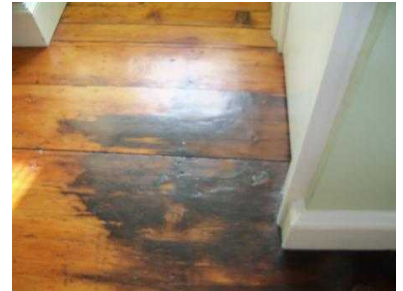
10. 3rd left Bedroom Floor: Pine [Loose flooring noted](#)

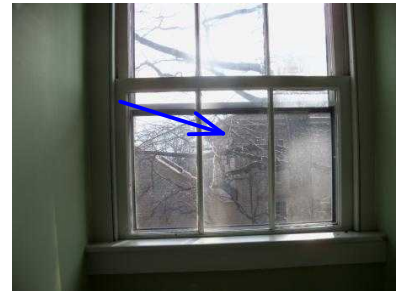
11. 3rd left Bedroom Windows: Double hung [Cracked pane noted at front window](#)

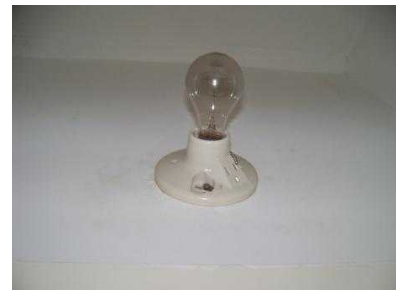
12. 3rd right front Bedroom Electrical: 110 VAC [Exposed light bulb noted in closet. This is a potential fire hazard if close or storage items come in contact with bulb.](#)

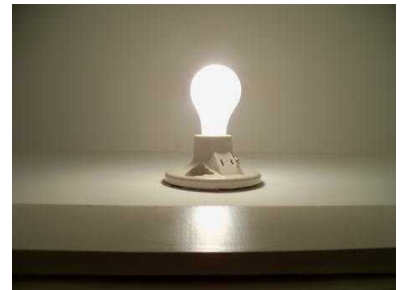
13. Master Bedroom Electrical: 110 VAC [Exposed light bulbs noted in closets. This is a potential fire hazard if close or storage items come in contact with bulb.](#)

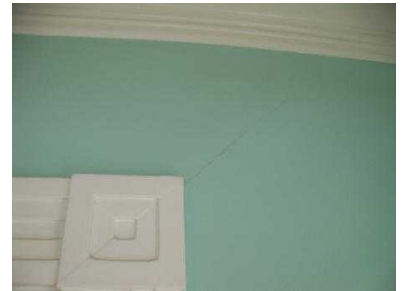
14. 2nd left front Bedroom Walls: Plaster [Crack noted above entry door](#)

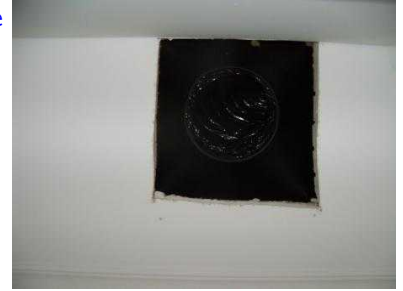
15. 2nd right rear Bedroom Ceiling: Plaster A/C duct in closet needs to be sealed off.

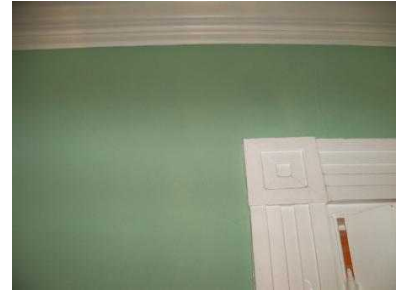
16. 2nd right rear Bedroom Walls: Plaster Cracks noted above entry door.

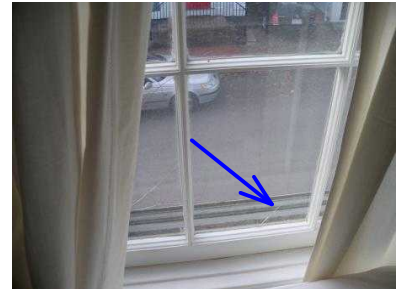
17. 2nd right rear Bedroom Windows: Double hung Cracked pane noted at right side window

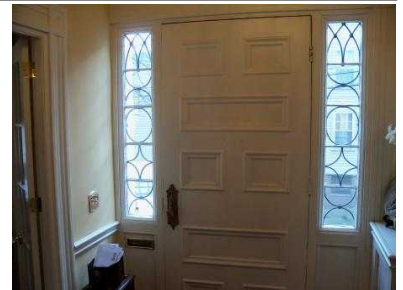
18. Foyer Living Space Doors: Wood Front door sticks at jamb

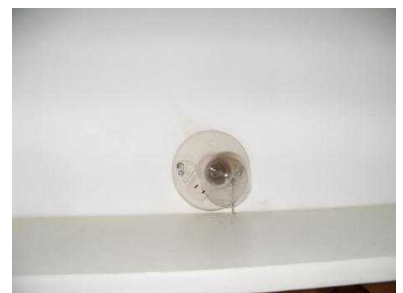
19. Foyer Living Space Electrical: 110 VAC Exposed light bulb noted in closet. This is a potential fire hazard if close or storage items come in contact with bulb.

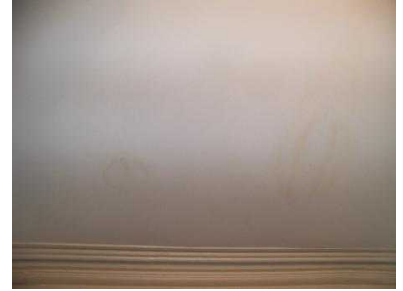
20. Living room Living Space Ceiling: Plaster [Inactive water stains noted](#)

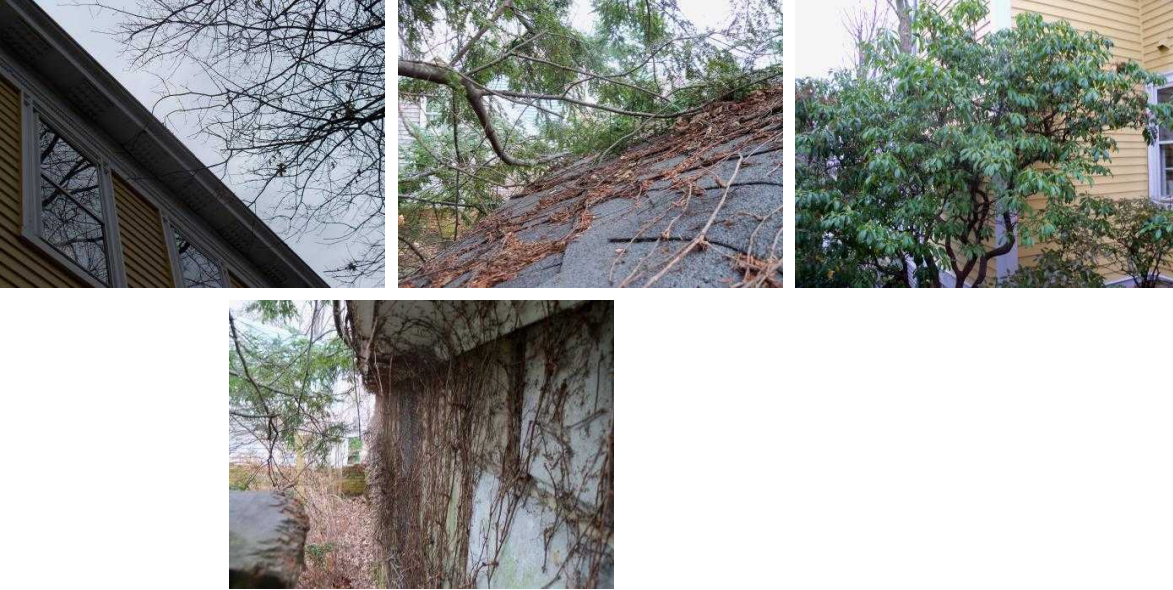
1. Vegetation: Trees/shrubs **Tree limbs are in contact with house and garage and need to be cut back. Trim vegetation back 1' from house and garage in order to prevent moisture damage to siding.**

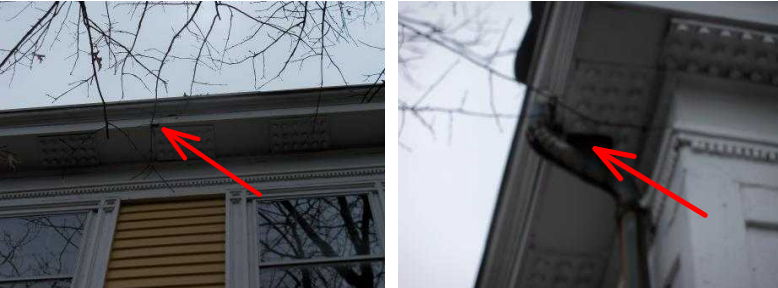
2. Soffits: Wood **Deterioration noted at front soffit.**

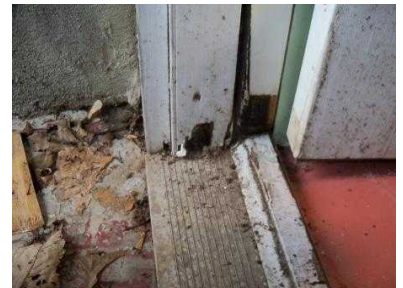
3. Entry Doors: Metal, Wood **Deteriorated jamb noted at basement door.**

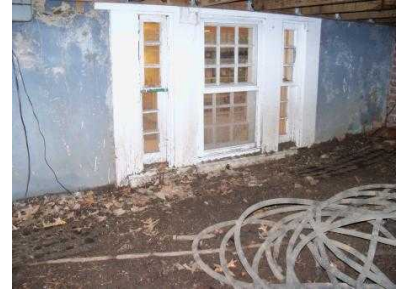
4. Basement Windows: Foundation style, Double hung **Deteriorated sill noted at left rear double hung basement window.**

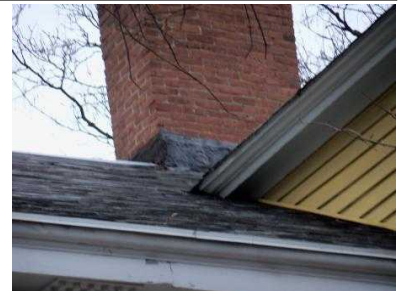
5. Center Chimney Chimney Flashing: Aluminum, Lead **Temporary tar repair noted. A qualified roofing contractor is recommended to evaluate and estimate repairs.**

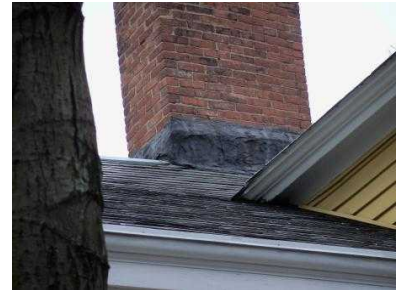
6. East Chimney Chimney Flashing: Aluminum, Lead **Temporary tar repair noted. A qualified roofing contractor is recommended to evaluate and estimate repairs.**

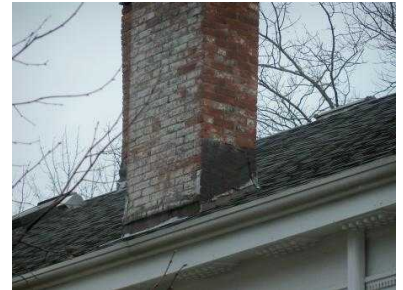
7. Northwest Chimney Chimney Flashing: Aluminum, Lead **Temporary tar repair noted. A qualified roofing contractor is recommended to evaluate and estimate repairs.**

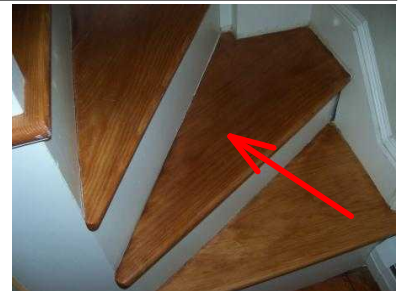
10. Stairs/Handrails: Wood stairs with wood handrails **Inadequate support noted at tread at wood stairs between 2nd and 3rd floor.**

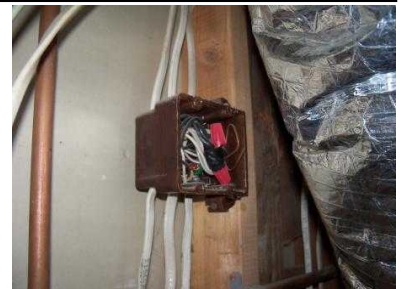
12. Electrical: 110 VAC **Cover needed at open junction box in boiler room.**

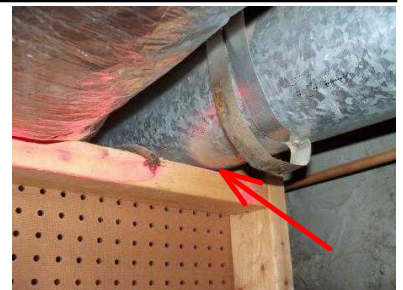
13. Basement Heating System Flue Pipe: Single wall **Inadequate clearance noted between vent pipe and combustibles.**

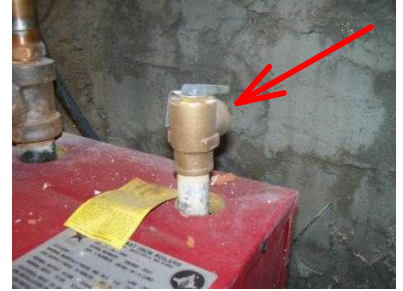
14. Basement Heating System Controls: Relief valve Missing discharge line noted

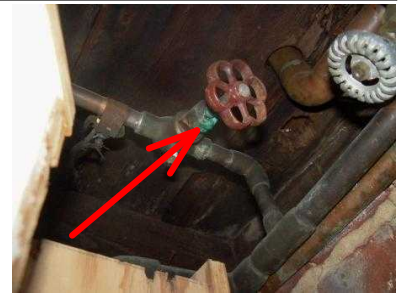
15. Water Lines: Copper Leaking gate valve noted behind basement bathroom access panel. A licensed plumber is recommended to evaluate and estimate repairs.

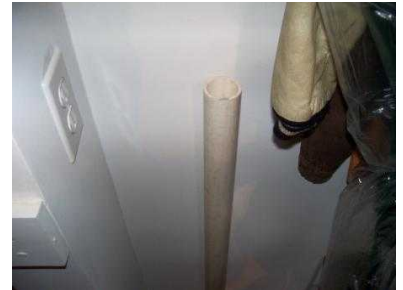
16. Drain Pipes: Cast iron, PVC, Copper Unused washer drain on 1st floor needs to be capped in order to prevent sewer gases from entering living space.

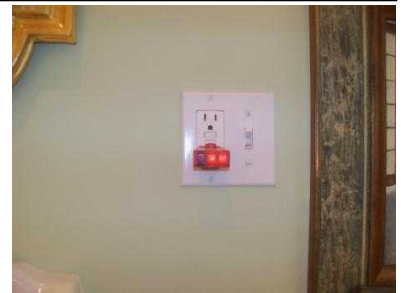
17. 1st floor Bathroom Electrical: 110 VAC GFCI Outlet does not trip when tested and requires replacement.

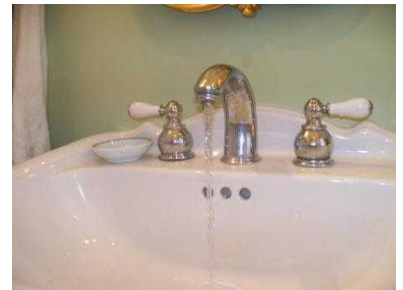
18. 1st floor Bathroom Faucets/Traps: Hot water at sink faucet does not turn off. A licensed plumber is required to evaluate and estimate repairs.
