# Cornerstone Home Inspection

33 Arnold Street  
Providence, RI 02906

Prepared for: Bruce Long

06:45 December 16, 2009

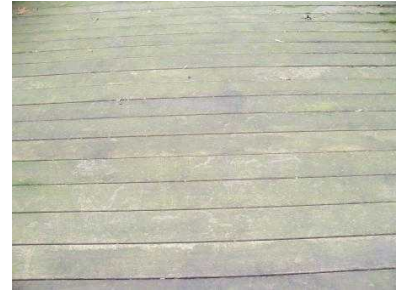
| 5. | <input type="checkbox"/> | <input type="checkbox"/> | <input type="checkbox"/> | <input checked="" type="checkbox"/> | <input type="checkbox"/> | Deck: Treated wood <span style="color: blue;">Clean and reseal</span> |

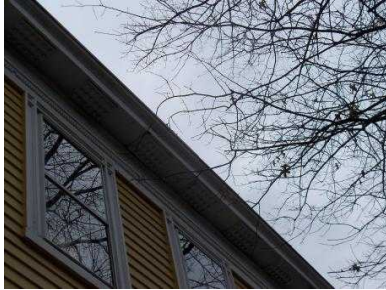
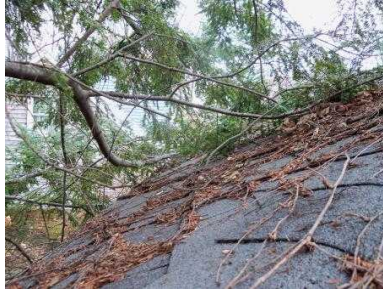
| 7. | <input type="checkbox"/> | <input type="checkbox"/> | <input type="checkbox"/> | <input type="checkbox"/> | <input checked="" type="checkbox"/> | Vegetation: Trees/shrubs <span style="color: red;">Tree limbs are in contact with house and garage and need to be cut back. Trim vegetation back 1' from house and garage in order to prevent moisture damage to siding.</span> |

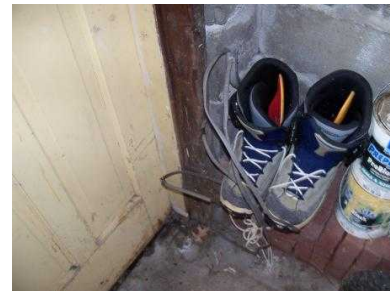
10.      Electrical: 110 VAC **Inoperable at time of inspection**

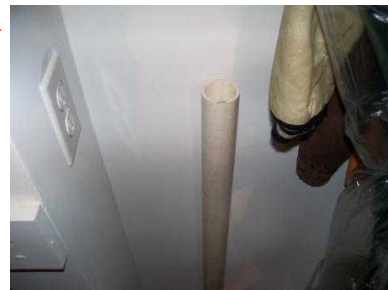
- 4.      Drain Pipes: Cast iron, PVC, Copper Unused washer drain on 1st floor needs to be capped in order to prevent sewer gases from entering living space.

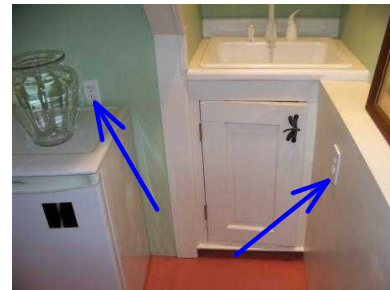
- 17.      Cooking Appliances: Premier
- 18.      Sink: Porcelain
- 19.      Electrical: 110 VAC GFCI outlets needed next to sink.

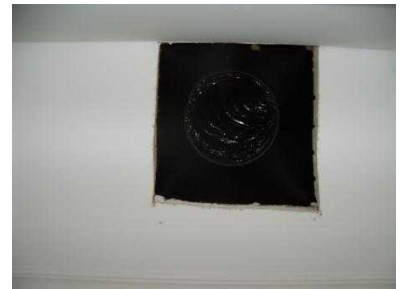
34.      Ceiling: Plaster A/C duct in closet needs to be sealed off.

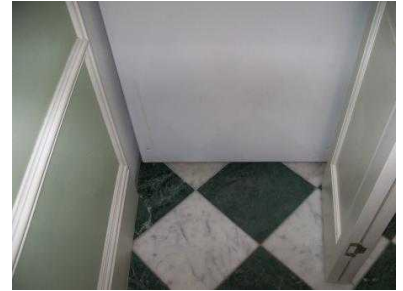
1.      Electrical: 110 VAC  
2.      Washer Hose Bib: Ball valves  
3.      Washer and Dryer Electrical: 110-240 VAC  
4.      Dryer Vent: Metal flex  
5.      Washer Drain: PVC  
6.      Floor Drain: Not present

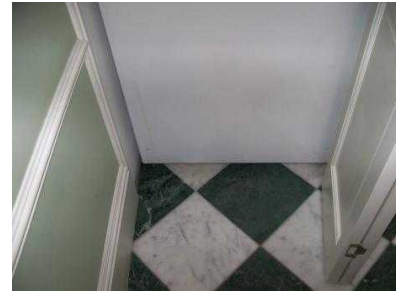
21. 2nd Floor Laundry Room/Area Floor Drain: Not present

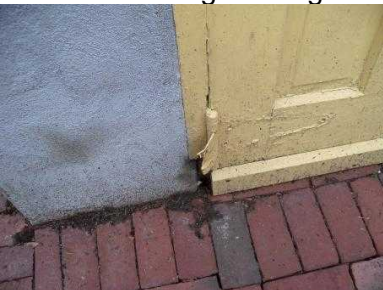
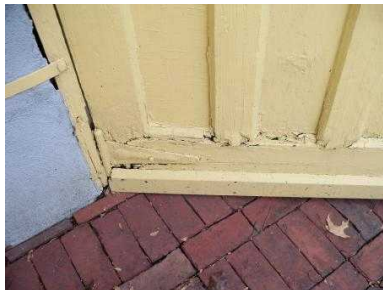
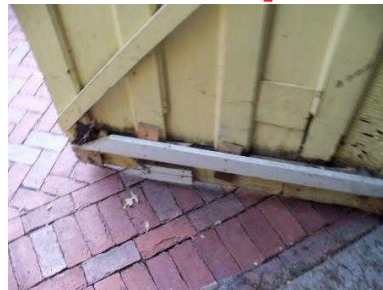
8. Detached Garage Garage Doors: Wood **Deterioration noted. Doors require replacement.**
